OLD BRANSON HIGH SCHOOL

ANALYSIS AND COST ESTIMATES

August 20, 2012

A study prepared for the City of Branson to assist in reviewing options for the Old High School property.

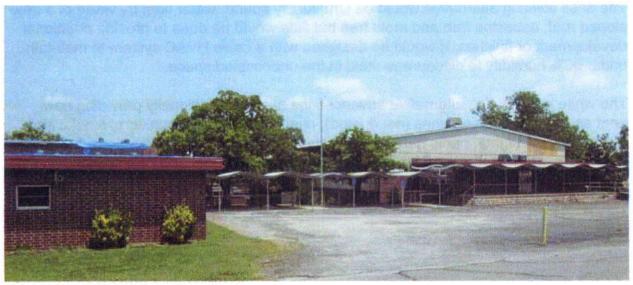
Above: Option 1 existing conditions

This option would correct structural issues and water leaks, remove the asbestos, remove the mold and lead paint (if found), provide limited heat and air conditioning to minimally control interior temperature and generally stabilize the building for future use.

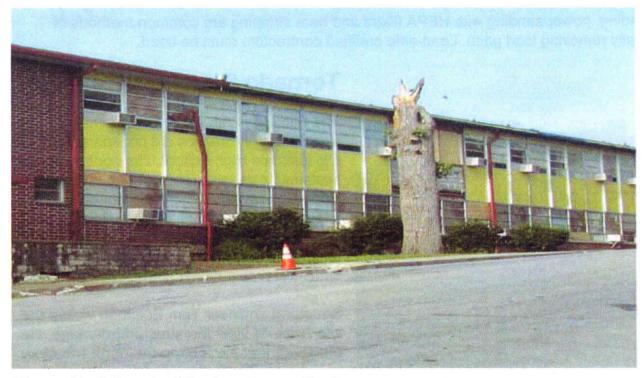
Structural engineer Tom Edelman visited the site twice to view the structural damage. He observed that the roof on the north two-story wing had been lifted up and then released to fall back onto the walls. The walls were out of plane when the roof came back down, thus they were trapped into that condition by the weight of the roof when it returned.

Most of the tornado damage occurred to the west end of the two story wing. Here, parts of the roof construction were separated from the wall. In addition, the roof was damaged to a level that allows rain and debris to enter into the interior spaces. The City has installed temporary tarps over the roof to limit exposure of the interior to the elements. However, the mold in this portion of the school is so extensive that it would be difficult to work in this area until the mold is abated.

Above: North facade of the two-story north wing.

have broken connections in some visible locations. The only way to know the extent of the broken connections would be to remove the roof. If it is desired to retain this wing, then the roof needs to be removed to expose the bar joists and their connections for examination. We would expect to find that the metal pan deck is also warped - however that cannot be observed until it is exposed.

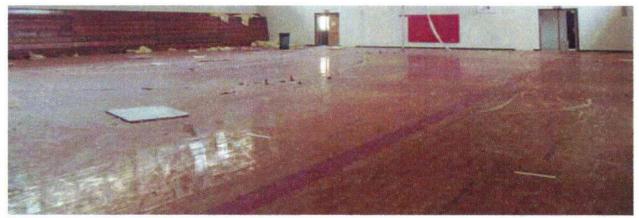
Above: Gym floor

Some communities have sought to preserve the memory of their own demolished schools by selling, or donating pieces of the gym floor to members and organizations of the community. These pieces of wood become visual reminders of basketball games, volleyball games and important transitional moments in one's life, such as graduation ceremonies. In fact, Branson won the state basketball championship in 1955 (v. Warrensburg) and 1958 (v. Thayer) (John E. Chase, coach.) If it is decided to demolish the building, reclaiming these boards would save them from the recycling bin, or, at the very least, might allow some of the boards to be retained as souvenirs while the rest is resold to the construction market or recycled. If the building is restored, the gym floor should be retained. In the interim it needs to be cleaned and protected.

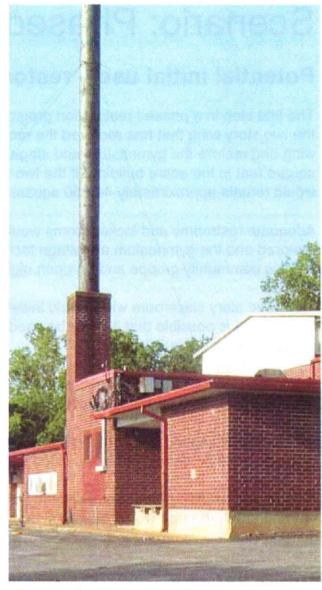
Above: Recyclable materials include iron from the boiler, copper pipes and wiring.

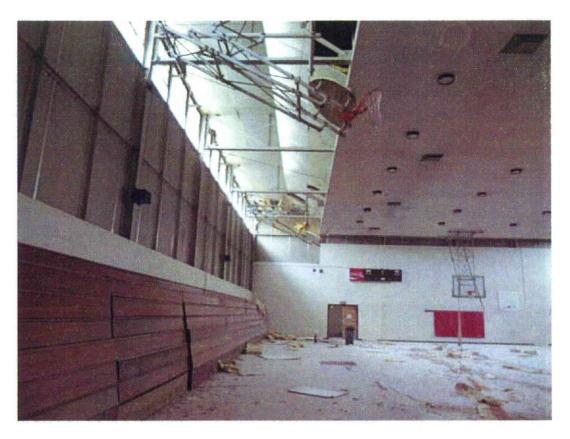
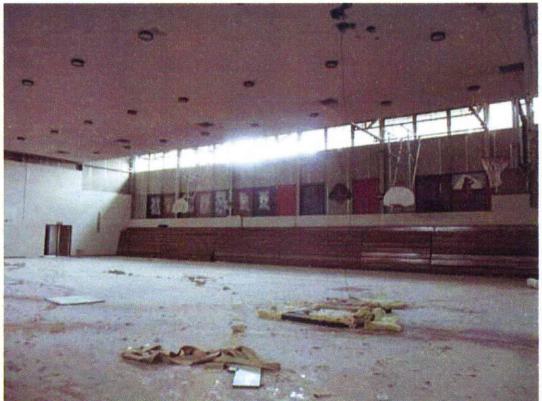
Above: Current state of gym.
